**FLY-ASH BASES IN THE ATLANTA DISTRICT:
EVALUATION OF SURFACE TREATMENT BOND
AND
YEAR-TWO FIELD PERFORMANCE EVALUATIONS**

Cindy Estakhri
Assistant Research Engineer
Texas Transportation Institute

Report 2966-2
Project Number 7-2966
Research Project:
Durability of Surface Treatments as the Wearing Course
Placed on Crushed Fly Ash and Long-Term Performance
of Crushed Fly Ash for Flexible Base

December 1998

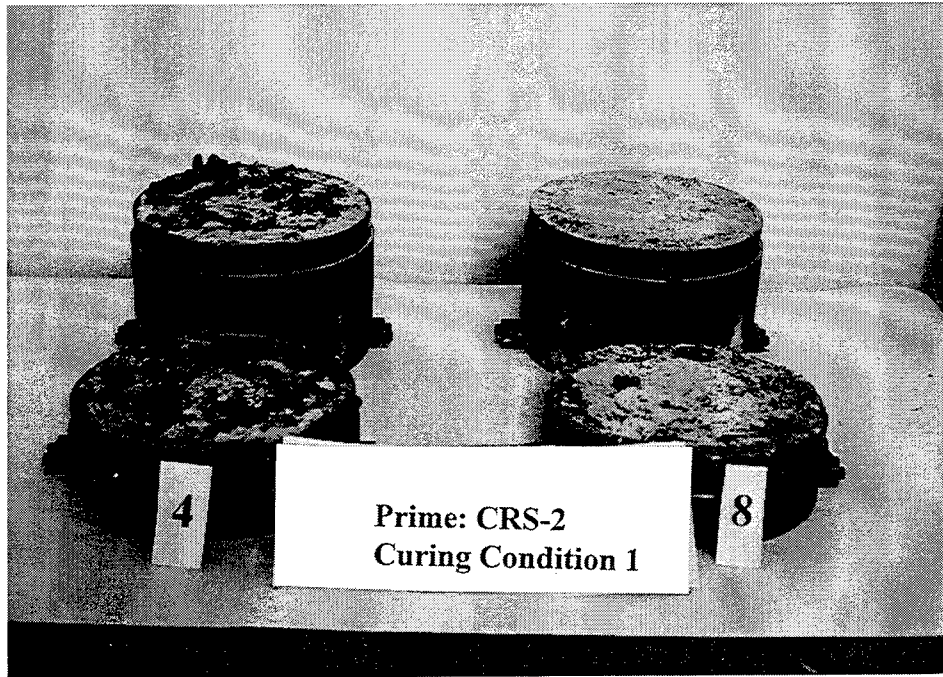
Figure 5. Failed Torsional Shear Test Specimens - CRS-2, Curing Condition 1.

A typical photograph of two of the failed specimens is shown in Figure 5 below. This photo shows the specimens for the CRS-2 prime material and curing condition 1. As shown in the photograph, failure occurred just below or at the interface of the prime and the base material. Note that the shorter specimens in front were sheared from specimens in back, i.e., failure plane is shown in photograph.

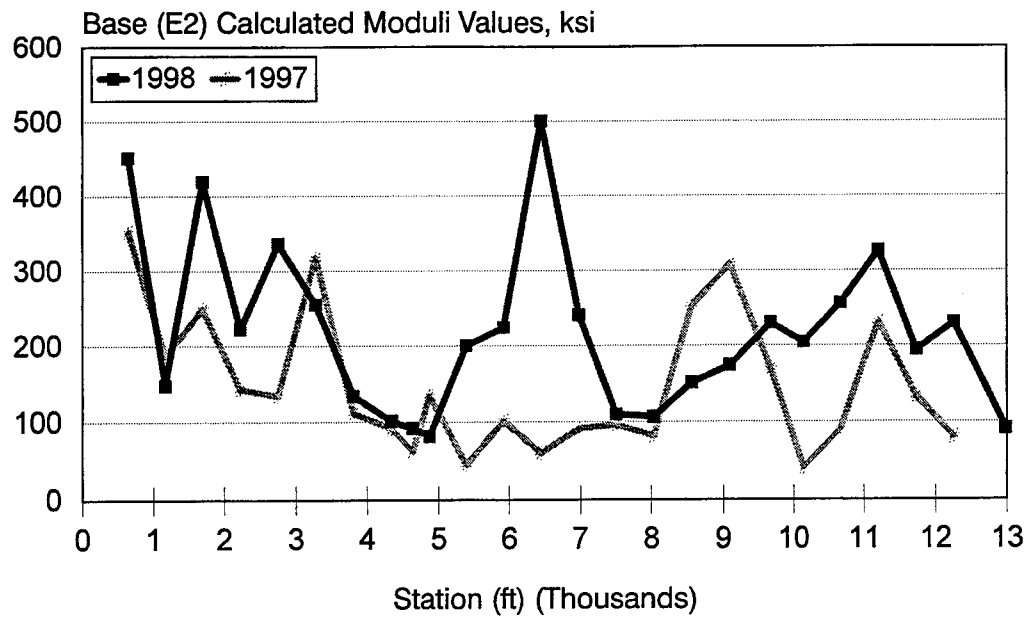
Figure 7. Base Moduli Values for Loop 390

FWD data shown in Table 8 and Figure 7 indicate that the base layer is weak in some areas which also coincided with areas where alligator cracking was observed in 1997. As shown in Figure 7, there is some variation in the moduli values between 1997 and 1998; however, the difference does not seem to warrant concern that the base is exhibiting a deteriorating strength.

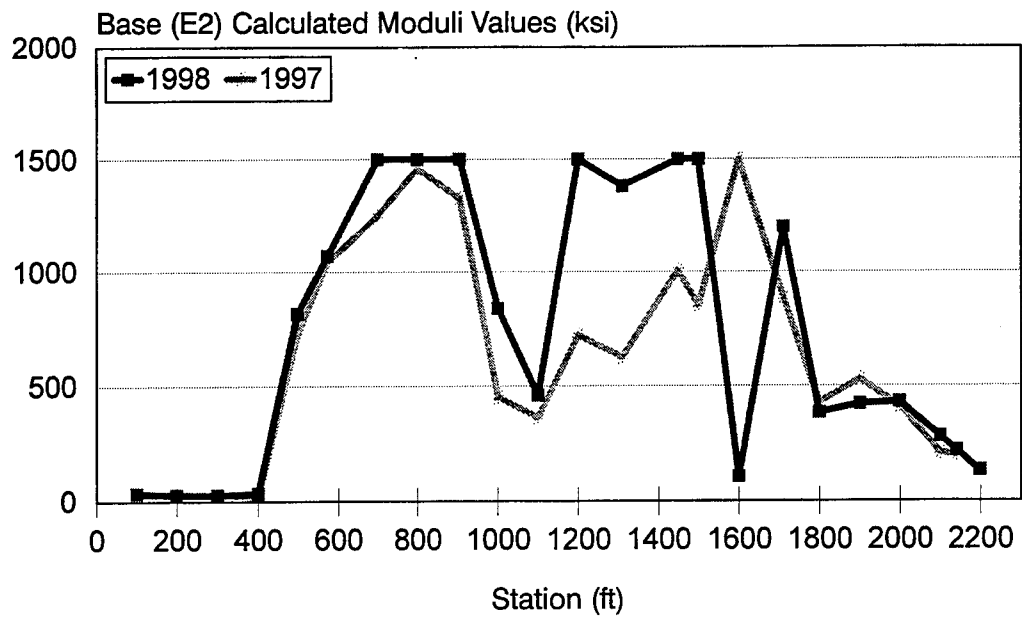
Figure 9. Base Moduli Values for SH 154

With indications of what appears to be shrinkage cracking, one would expect this pavement to be the stiffest of the six. This is true in terms of FWD data (Figure 9). Base moduli values along the pavement exceed 1,000,000 psi in some locations. Base moduli values in 1998 appear to be similar to that in 1997 with some places showing significantly higher moduli than the previous year. Compressive strength of the cores is also close to the values obtained the previous year (Figure 6).

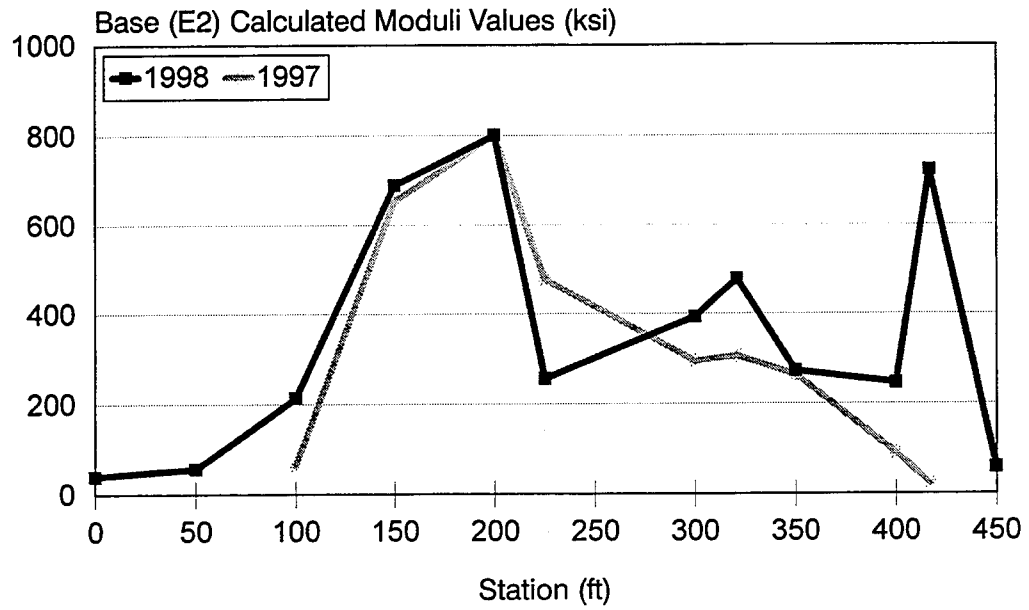
Figure 10. Base Moduli Values for FM 1326

Two cores were obtained from FM 1326 which could be tested and the compressive strength was significantly higher than the single core which was tested in 1997. FWD data (Table 12 and Figure 10) indicate that the base is not deteriorating but exhibits an overall similar or better modulus than the previous year.
